## 사 진 자 료

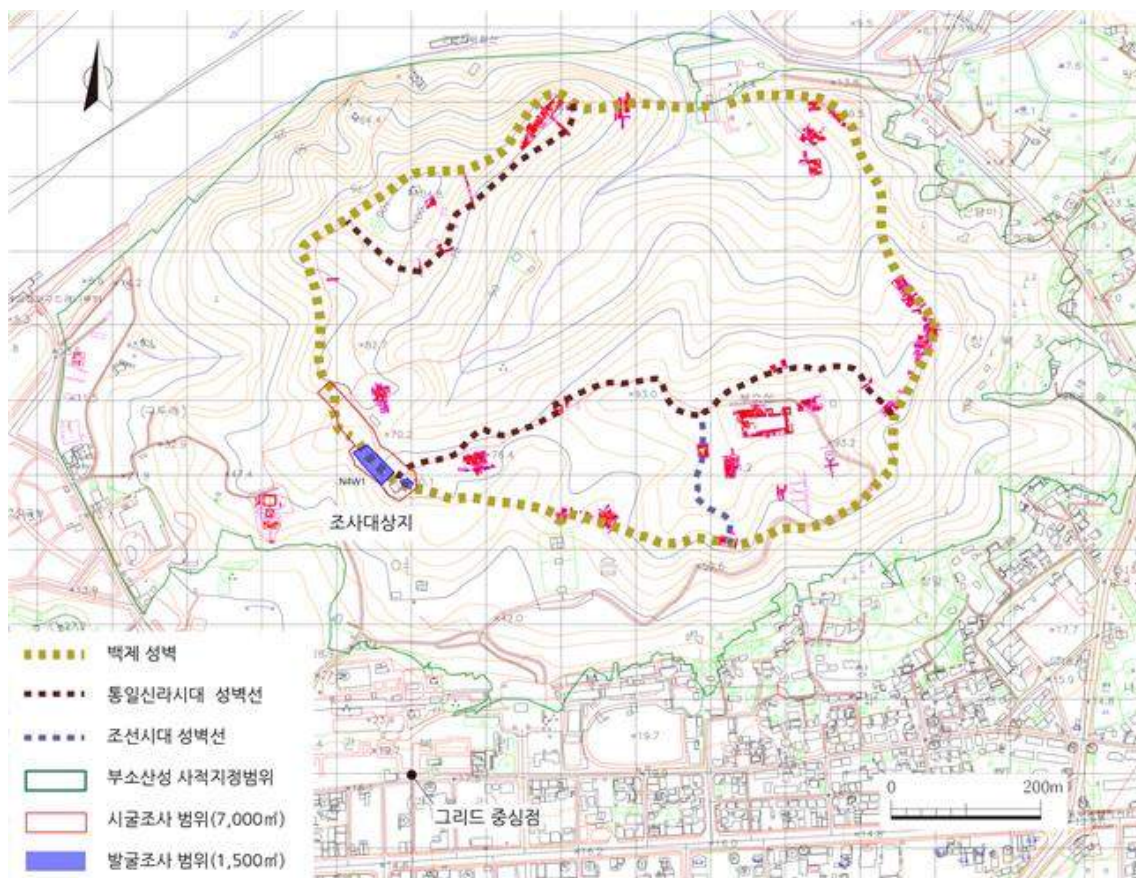
<부여 부소산성 성벽 현황과 조사지역의 위치>

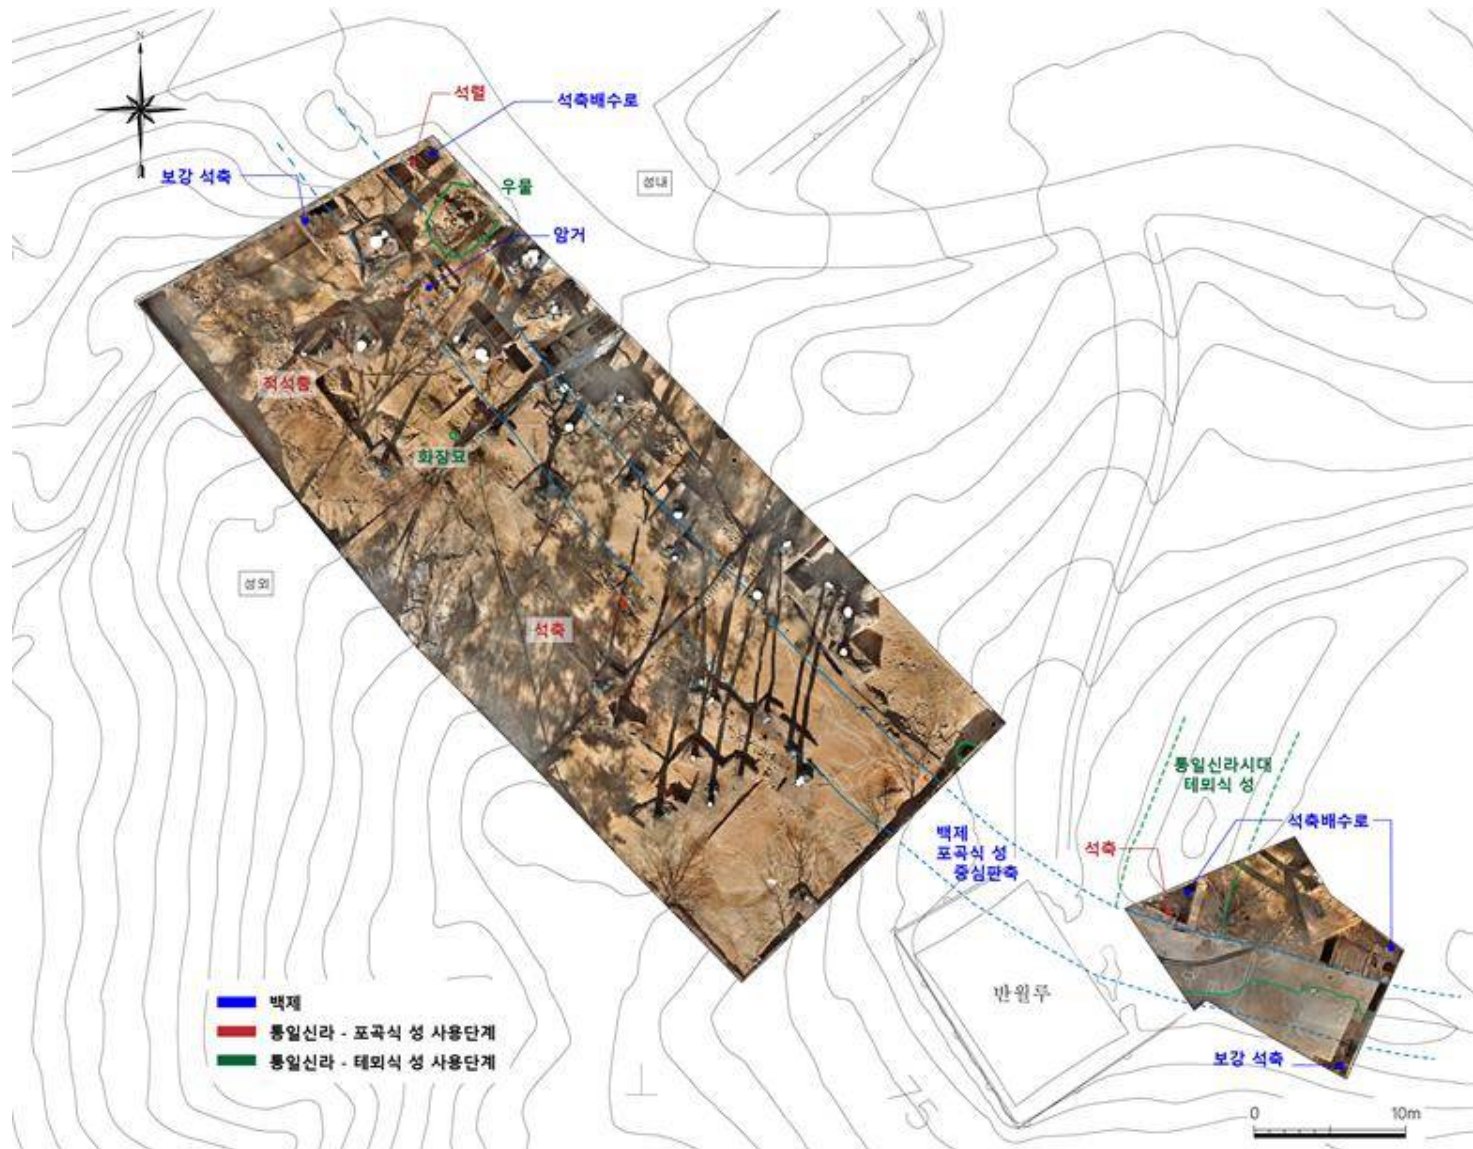
<부여 부소산성 발굴조사 유구 분포도>

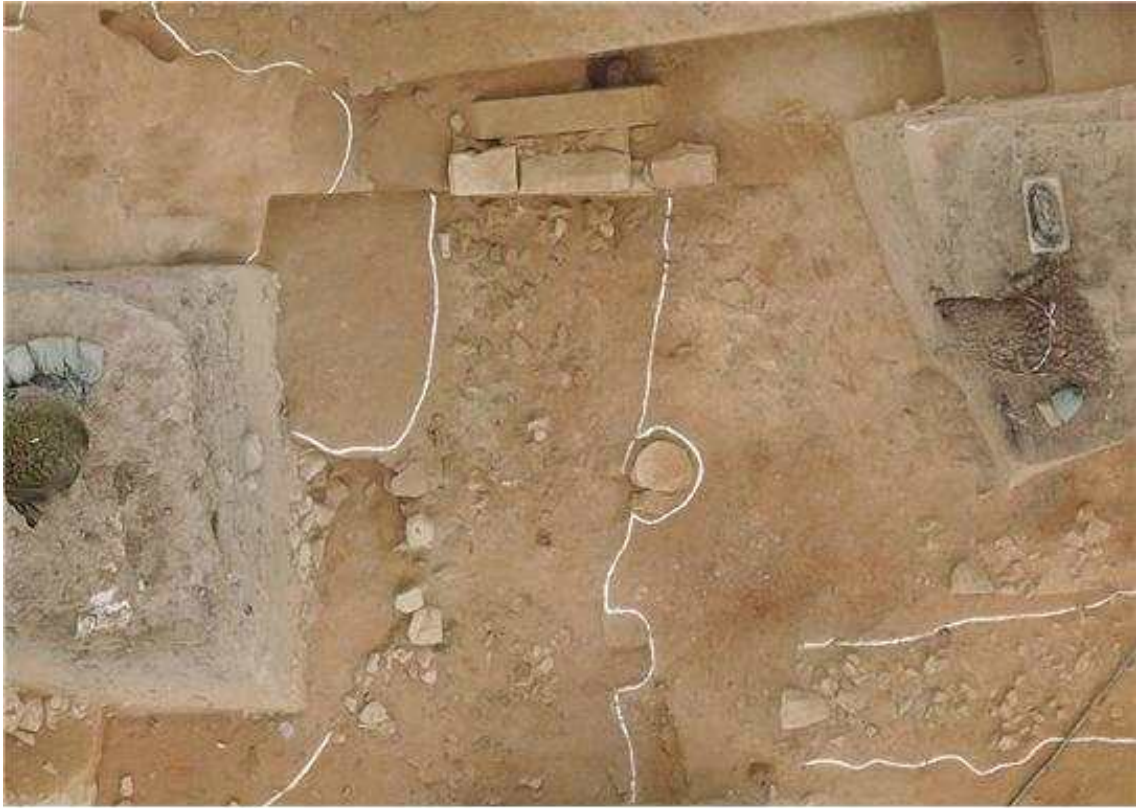
<백제 추정 서문지(성벽 암거와 상부에 매립된 대형 가공석재)>

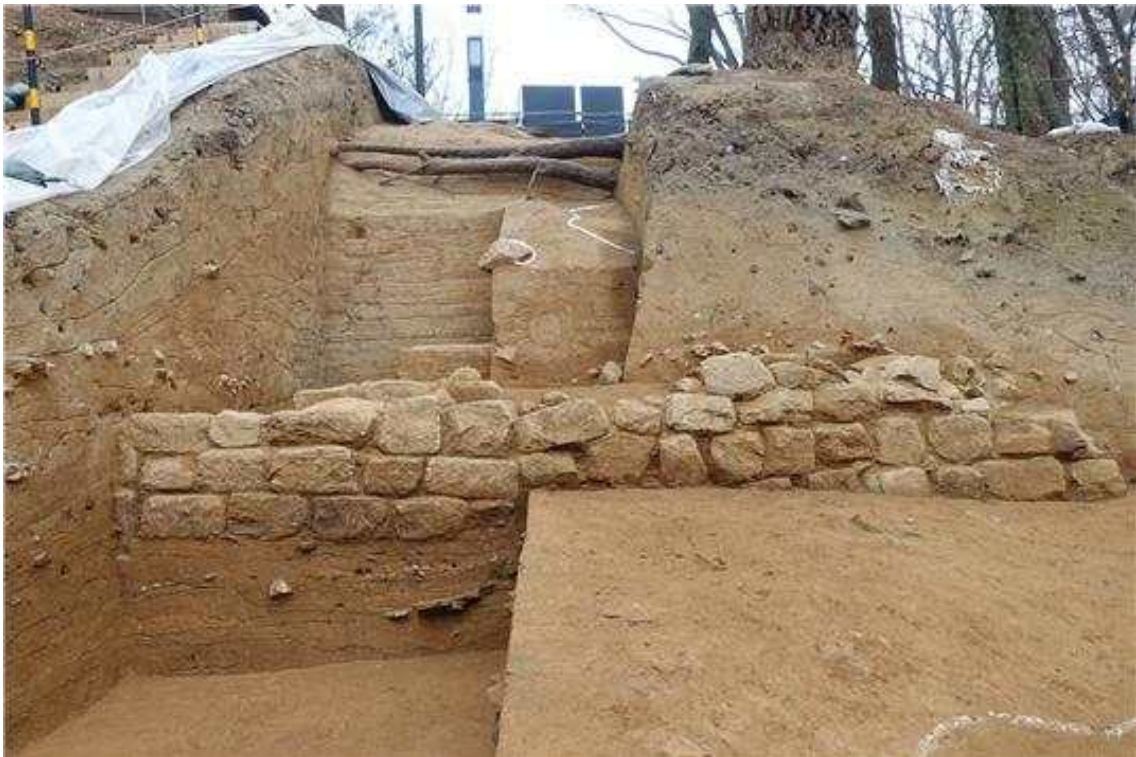
<백제 성벽 바깥의 보강 석축>

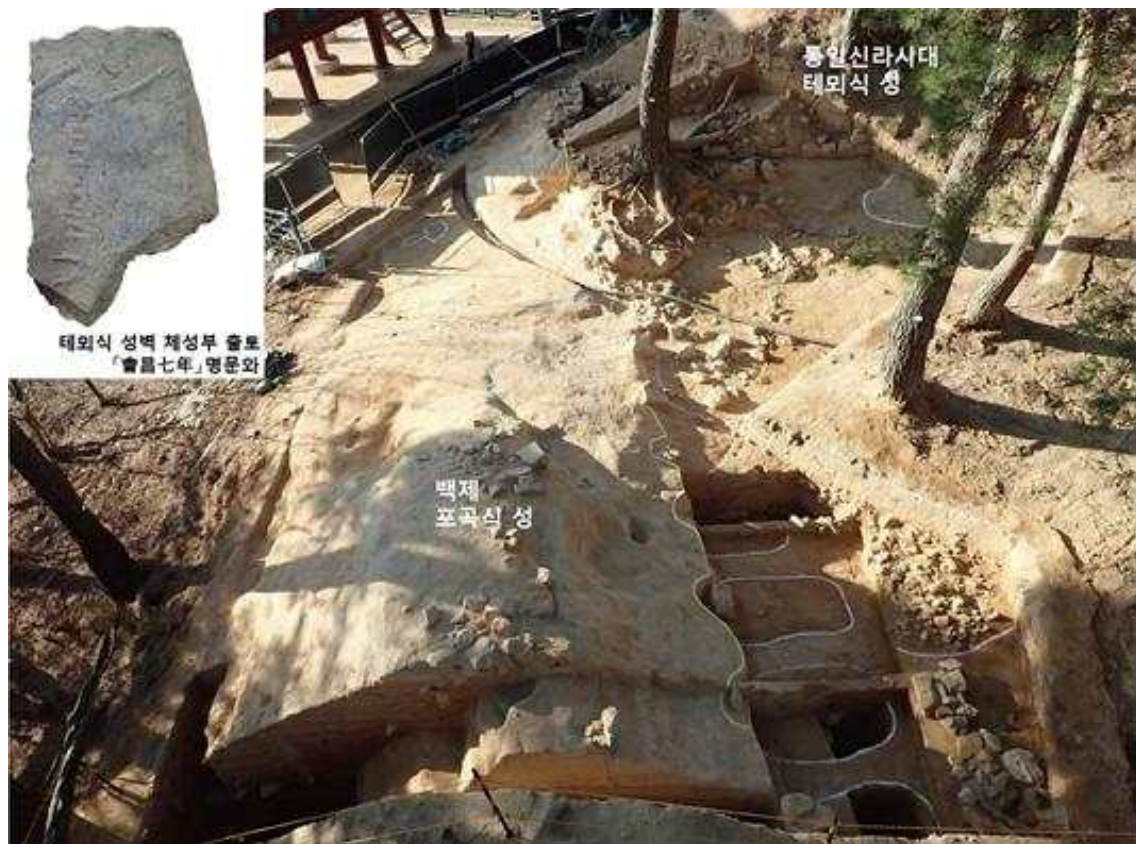
<백제와 통일신라 성벽 연결 지점 현황 >

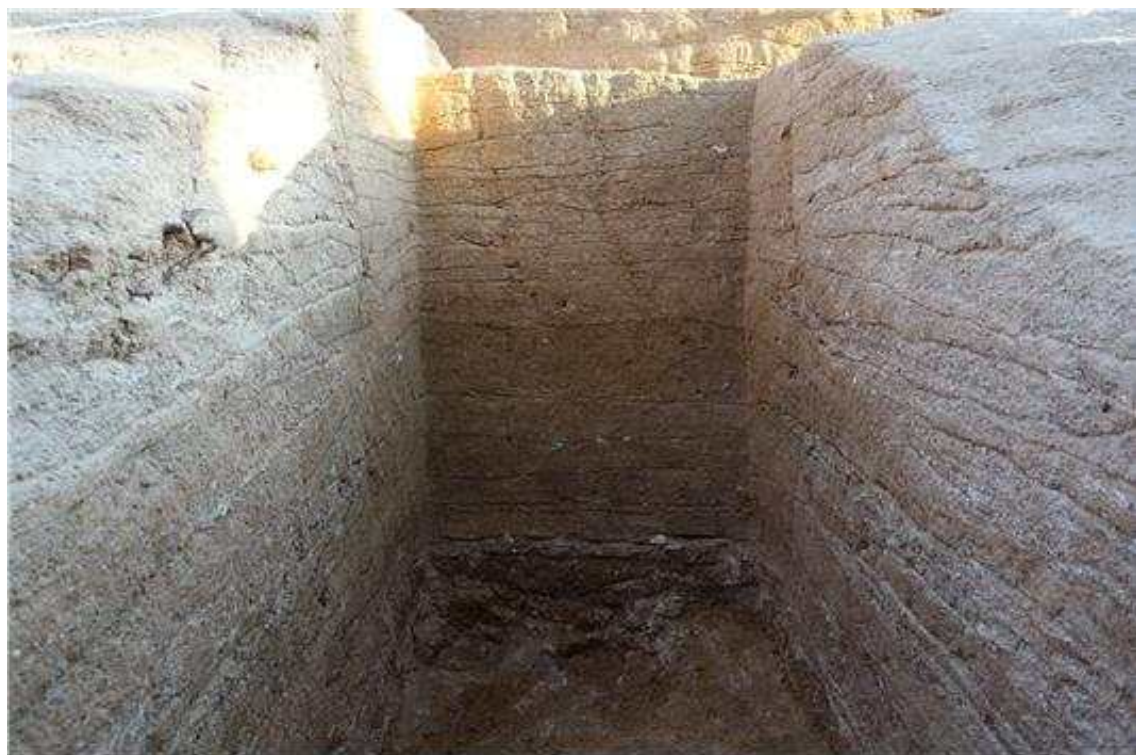
<추정 서문지 동쪽 성벽 관측 모습>
